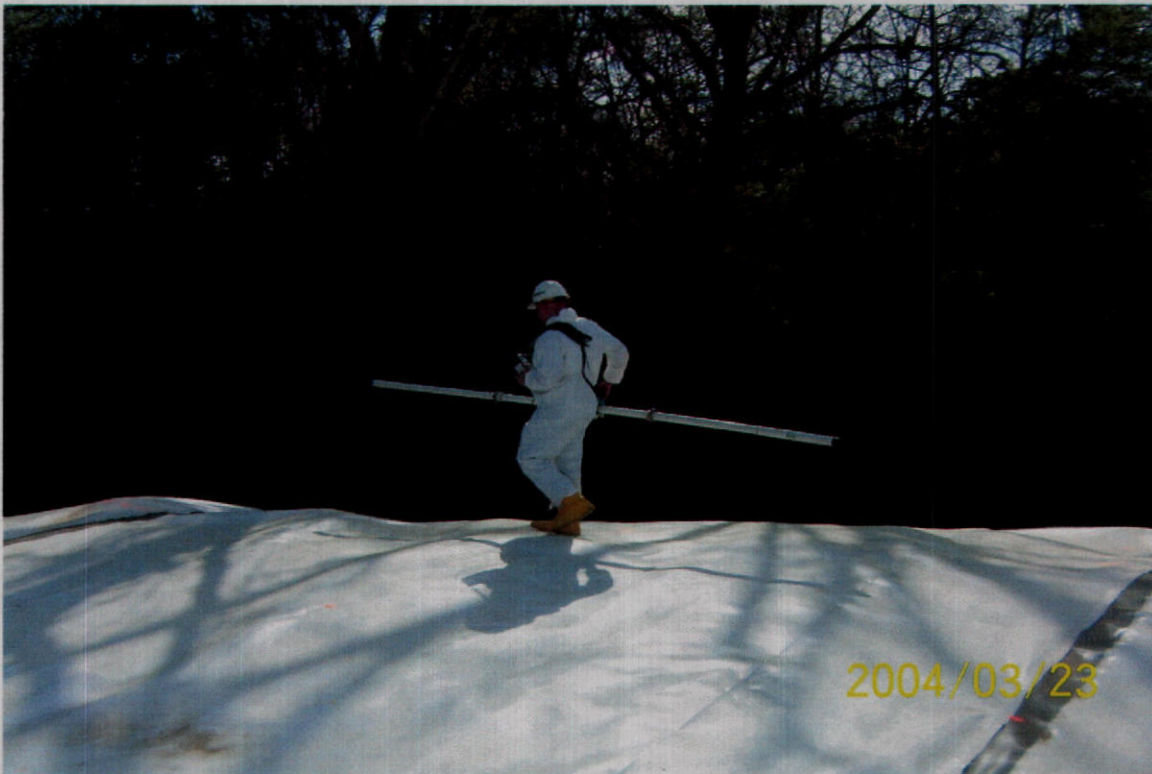
PHOTO 4 – View of the Schnabel Engineering project manager gathering data for the electromagnetic (EM) study portion of the geophysical survey. The EM study was conducted to identify areas containing metallic debris.
